NATURALHY

Sensitivity analysis of Clock Spring repair to Hydrogen gas-Effect on burst pressure

D35

Report No. D0020-WP4-P-0

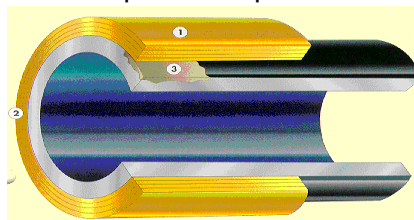
Figure 1: Clock Spring description

- ① Glass fiber
- ② Bi- component high strength adhesives
- ③ Filler: high compressive strength bi-component resin

NOTE: for internal defect, no filler.

This product is distributed by Clock-Spring Co. [4], under license of NCF Industries Inc. The system consists in composite material with a polyester matrix and a type E glass fibres reinforcement, pre-fitted and pre-streined in a cylindrical coil of 8 layers (cf. figure 1). So, for a given diameter, the Clock Spring thickness is always the same. Fibres are continuous in the wrap and oriented circumferentially, in order to strengthen the wrap in the hoop direction. The implementation of a Clock-Spring wrap requires three different components:

- A composite coil, pre-fitted to the pipe diameter,
- A methacrylate adhesive, allowing to bond the composite to the pipe, and the successive layers of the coil one to another,
- A high stiffness filling resin, allowing the load transfer between the defect to be repaired and the composite wrap.

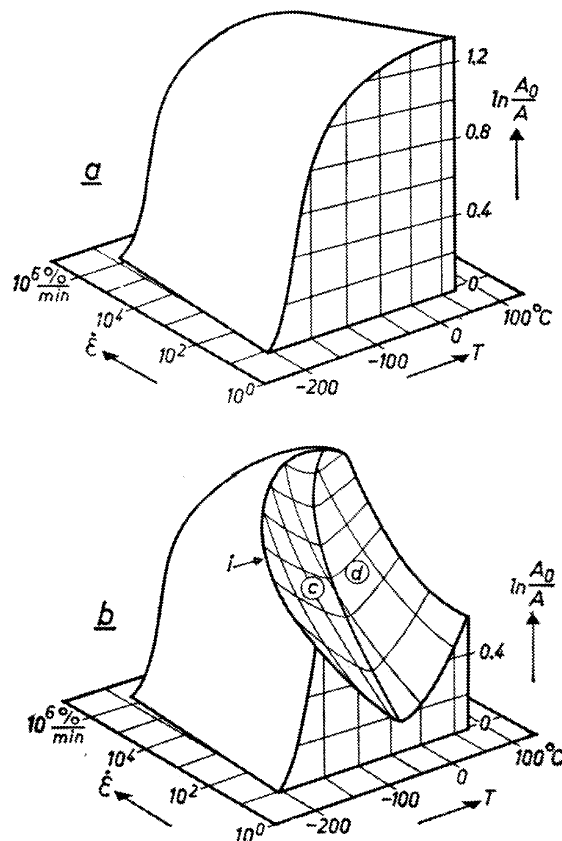
Fig. 2 True tensile strain at fracture  $\ln A_0/A$  versus temperature  $T$  and strain rate  $\dot{\epsilon}$ , for steel  
a) annealed, b) charged cathodically for 1 h in 4 % sulphuric acid (blisters were observed).

Figure 2 illustrates the origin of the term ‘hydrogen embrittlement’. When a tensile test is conducted on a steel specimen at room temperature in air, the strain at fracture is slightly dependent of strain rate, while the cold temperatures have a significant effect on the embrittlement. This is not the case when the specimen is immersed in a hydrogen-containing environment (such as a gaseous medium containing molecular hydrogen gas) [5]. In hydrogen tests, the ductility decreases when the strain rate diminishes. Hydrogen embrittlement steel is also shown by the fracture surface. Unfortunately, the worse case which promotes the brittleness happens at room temperature and low strain which are the conditions of pipelines in service.

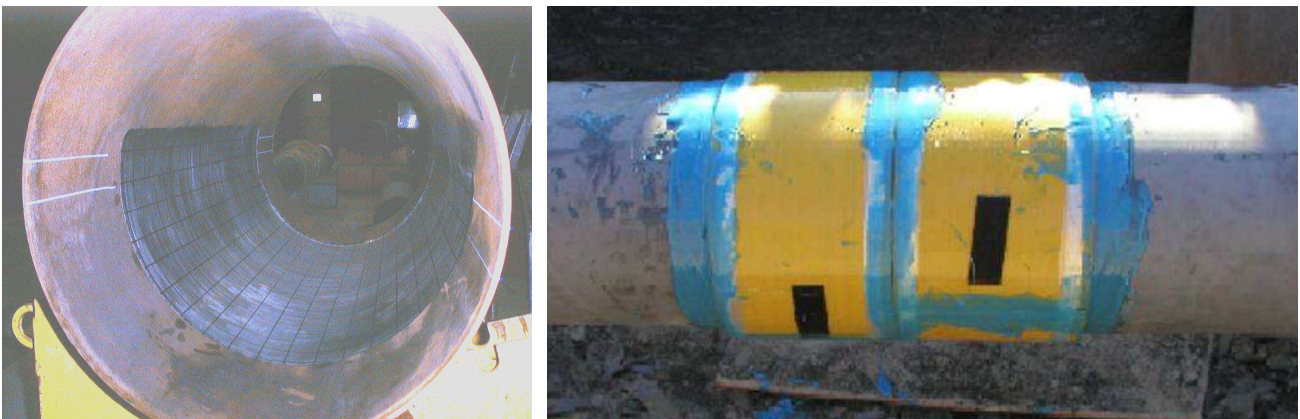
Figure 3 : Internal metal loss and Clock Spring

The capacity is composed of the portion of pipe with the defect (an internal metal loss), and of 2 cuffs reinforce comprising dished bottoms. The tube and the cuffs are welded; the thickened tube is machined to ensure a progressive transition to the level from the welding in the thickness. Figure 3 shows the view of the internal metal loss in the pipe and the Clock Spring

An internal metal loss has been machined in a 203° angle of the circumference of a 24" (609.6mm) diameter pipe. Pipe and defect geometries are given in tables 1 and 2

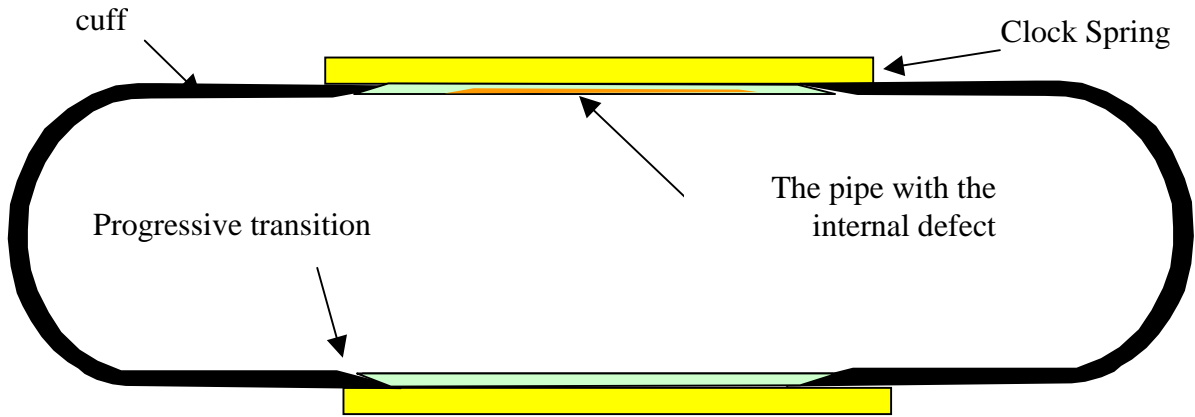
Figure 4 : Longitudinal length of the test capacity

Figure 4 represents a longitudinal cut of the capacity with the defect and the Clockspring

The defect was machined by a millstone to obtain a uniform internal metal loss.

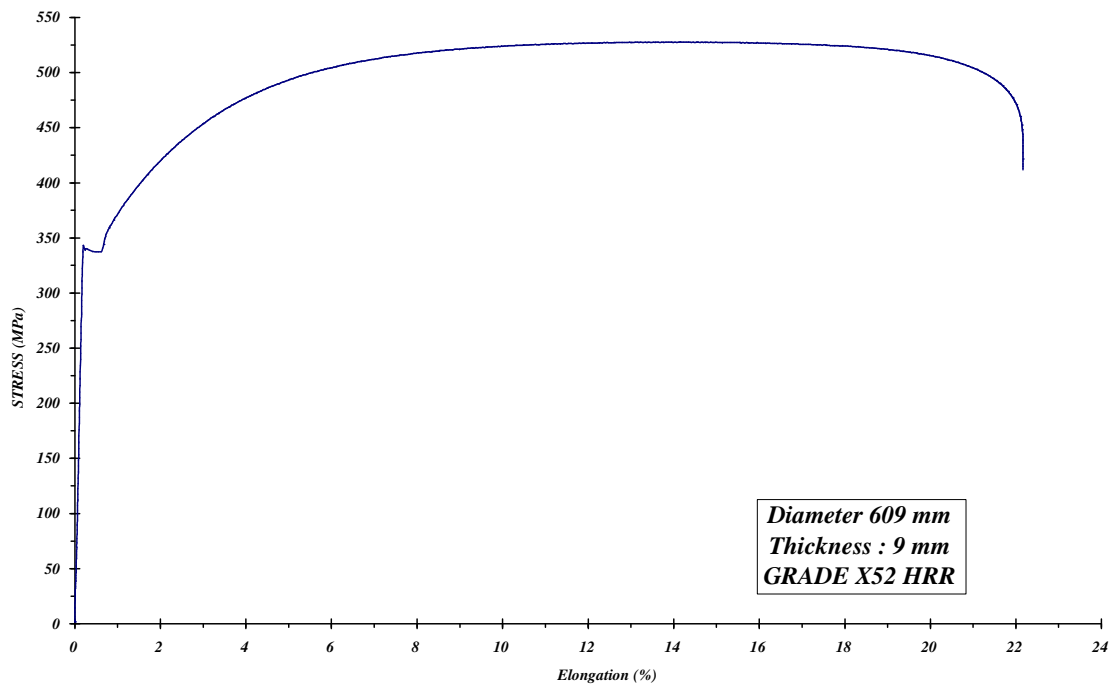
Figure 5 : Conventional tensile curve

The tensile properties and the mechanical behaviour of the pipe steel are given in Table 3 and Figure 4 :

Young's modulus (MPa)	210 000
Yield strength (MPa)	390
Ultimate Strength (MPa)	509
Average elongation of rupture	23%

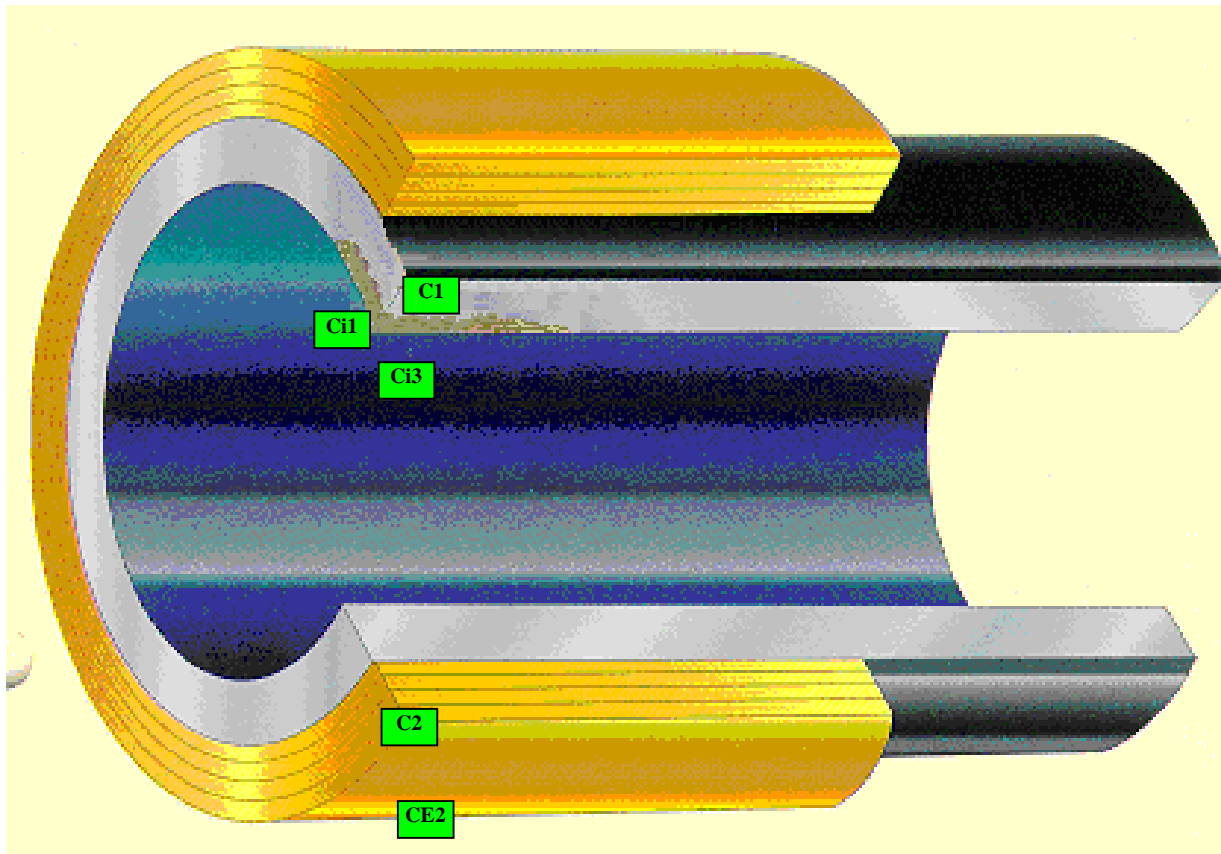
Figure 6: Emplacement of the gauges

To record the strains during the pressure test, circumferential and longitudinal gauges are stuck in different places:

- on steel in the defect generally in weak zones (fillets, under-thickness), (C1, Ci1, Ci3). C1 is on external steel surface under the Clock-Spring, Ci1 and Ci3 on internal surface defect
- on steel and under the Clock-Spring at the opposite to the defect, (C2)
- on Clock Spring at the opposite defect. (CE2)

The gauges positions are showed in figure 6 and the displacement sensor in figure 7.

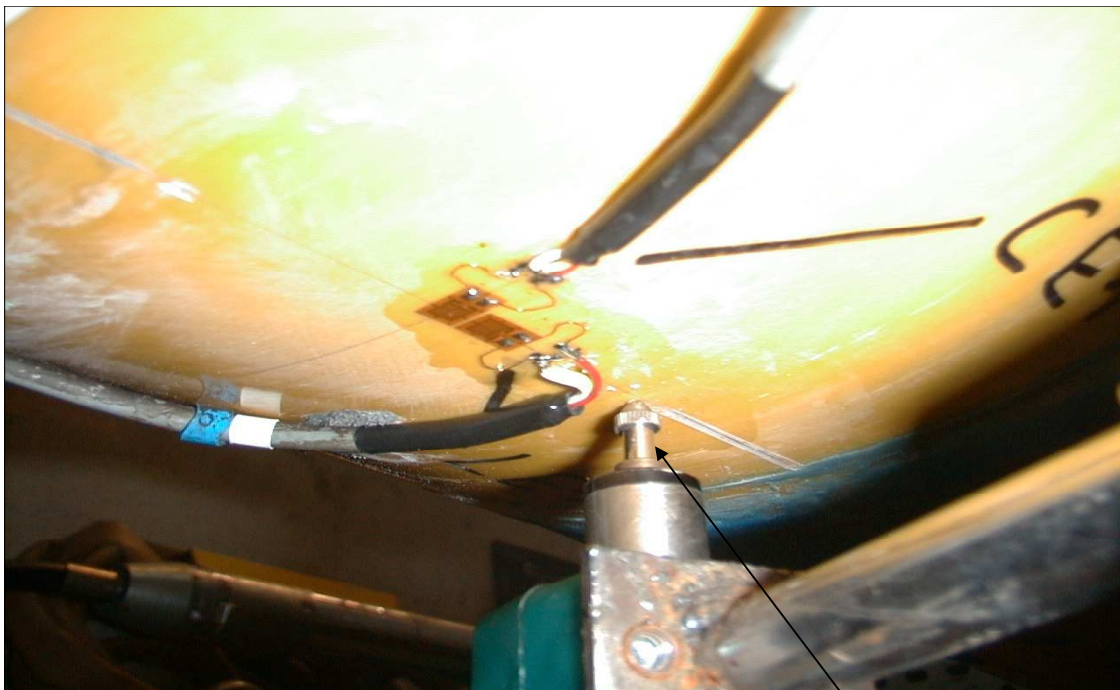
Figure 7: LVDT

A displacement sensor (LVDT) is placed on the defect.

displacement sensor (LVDT)  
on CS in the centre of the  
defect beside gauge CE1

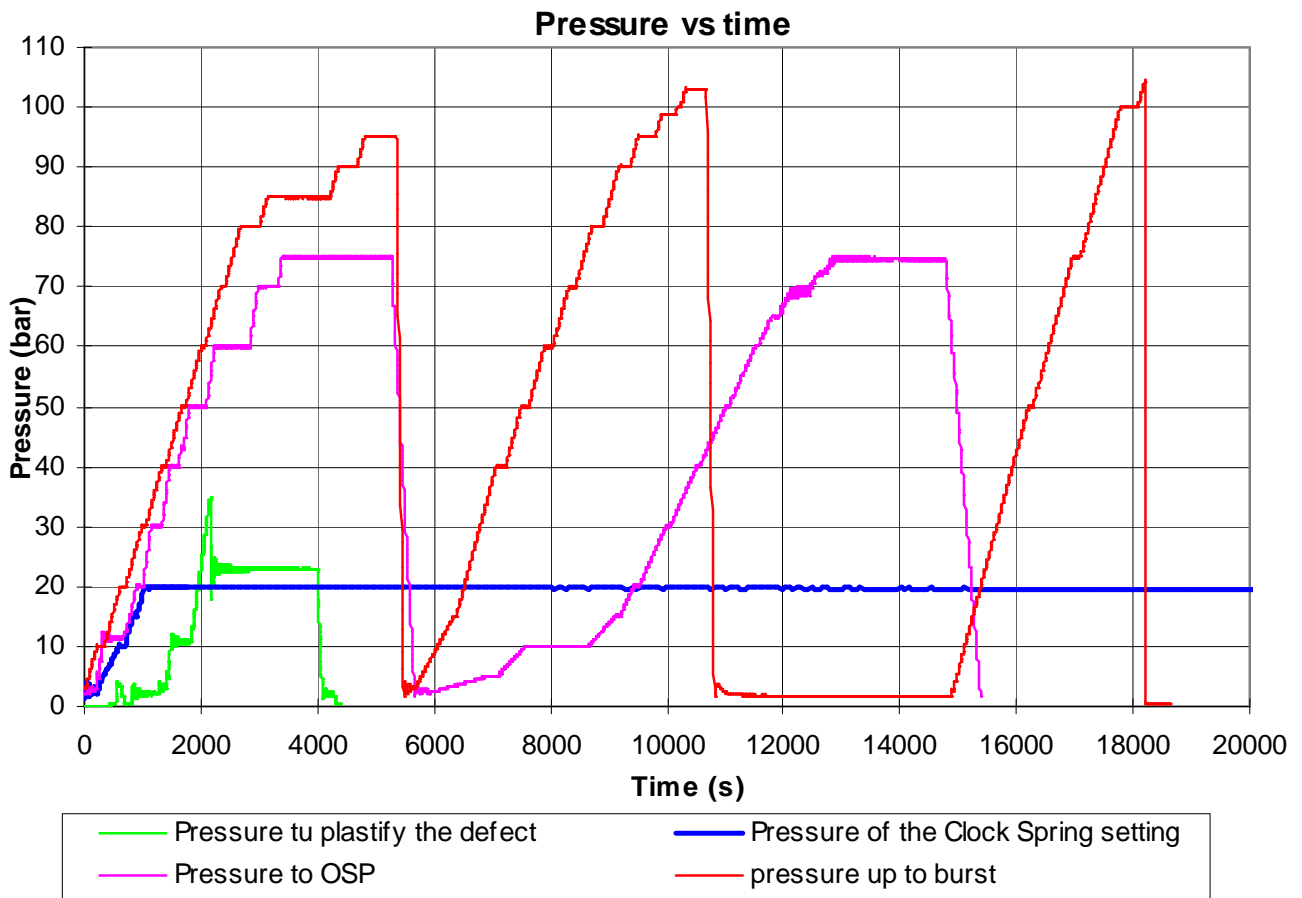
Figure 9 : Pressure load graph

1. Increase the pressure to plastify the defect at 1% of deformation. (35 bar)
2. Decrease the pressure to 0 bar before the putting of the Clock Spring
3. Increase the pressure to 20 bar for putting the Clock Spring
4. Putting up the Clock Spring at 20 bar
5. Decrease the pressure to 0 bar
6. Increase to the pressure OSP (Operating service pressure) at 75 bar for checking the behaviour of the defect reinforced with the Clock Spring
7. Decrease the pressure before the step of the burst
8. Increase the pressure to the burst pressure.

For reasons of a technical nature, the rising of the pressure proceeded three times before the burst.

The pressure versus the time is recorded. The figure 9 summarizes the pressure load.

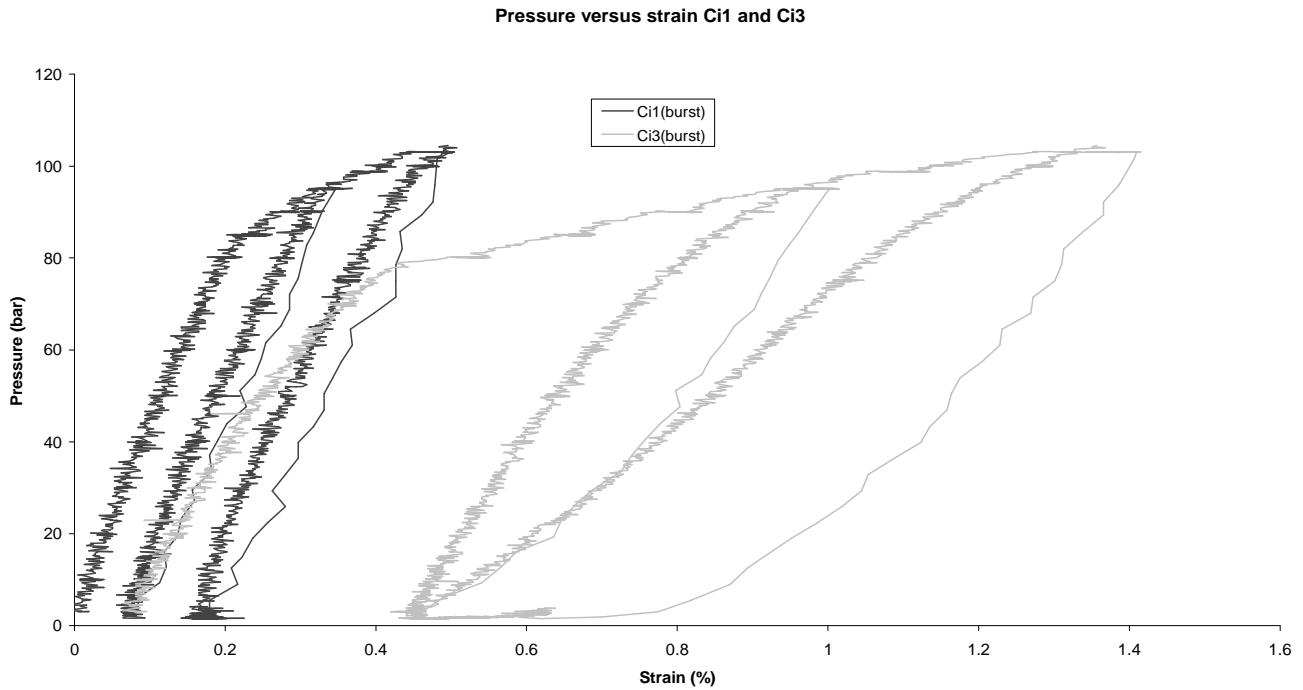
Figure 10: Evolution of the internal circumferential gauges positioned in the defect

The rupture reached in steel, near the gauge Ci3. The evolution of the Ci3 gauges (near to the rupture) and Ci1 (far away from the rupture) during the phase of failure clearly shows that the deformations are not homogeneous in the defect (figure 10).

The Ci3 gauge is at the deeper place of the defect with 77% of metal loss. At the Ci1 gauge, there is 72% of metal loss. So, with 5% of difference of the metal loss, the Ci3 gauge is more strained than Ci1. So the strain is high in the place of the less thickness.

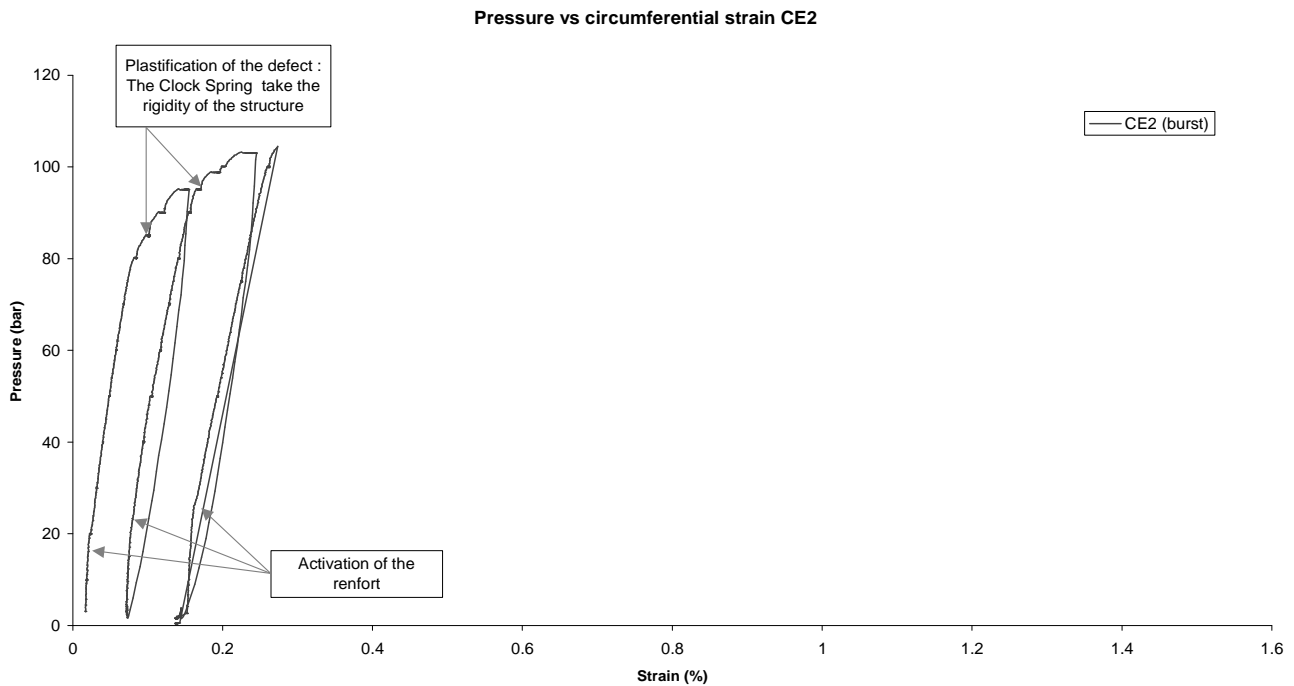
Figure 11: Evolution of the gauge located on the sleeve in the opposite to the defect at the time of the phase of failure

The evolution of CE2 gauge positioned at the opposite to the defect, during this same phase of failure, highlighted well the various aspects of the reinforcement brought by Clock Spring (figure 11):

- For pressures lower than the setting load (here, 20 bar), the sleeve is not requested and practically does not become deformed (CE2)

- For pressures higher than the setting load, one has activation of the reinforcement; the efforts are then transmitted to the whole of the sleeve,

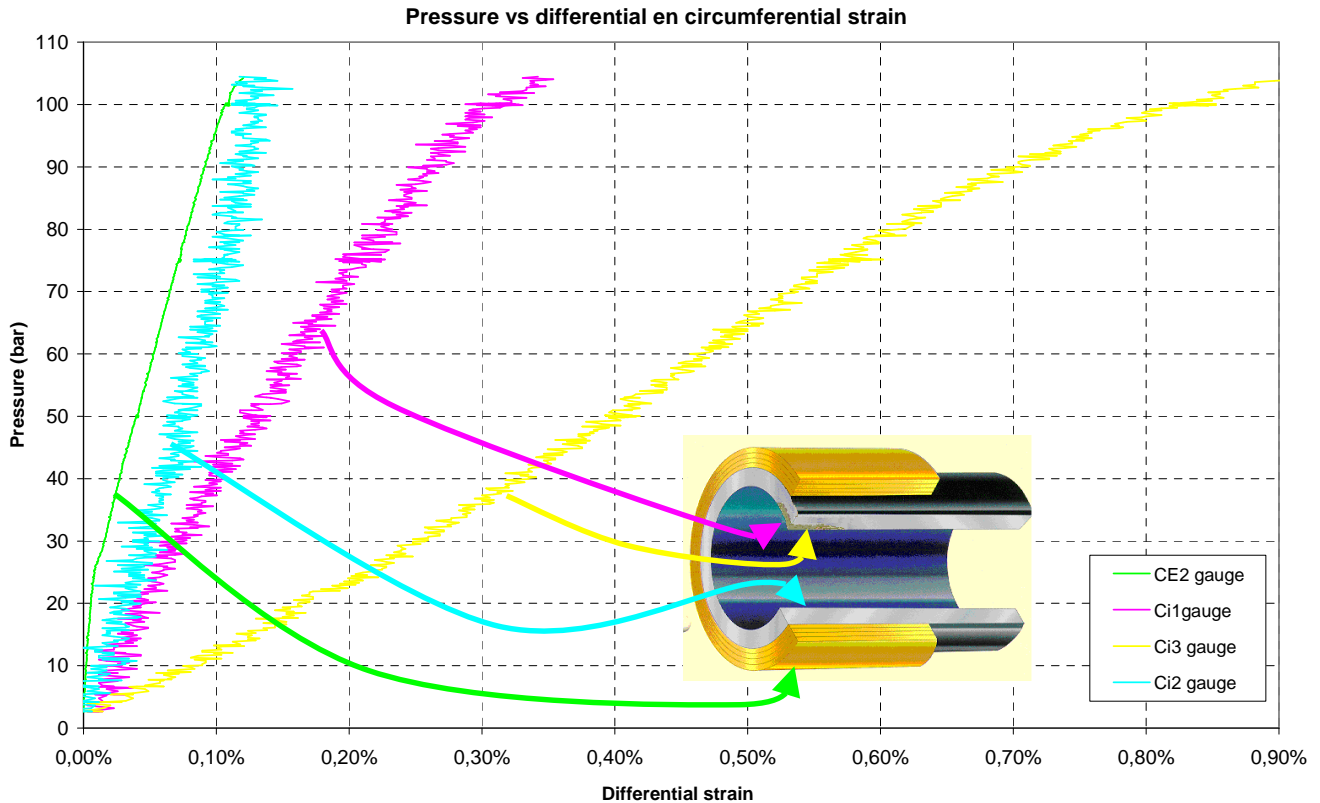
Figure 12: Differential strain from gauges during the burst

Figure 12 shows that a defect of the type of internal metal loss holds to inflate under the action of the internal pressure.

With the burst, the rupture reached in steel first, near the gauge Ci3. It is the place of the less thickness. The rigidity of the structure is then assured only by the sleeve in the place of the defect.

So, for this burst, the failure has been occurred at a pressure of 105 bar.

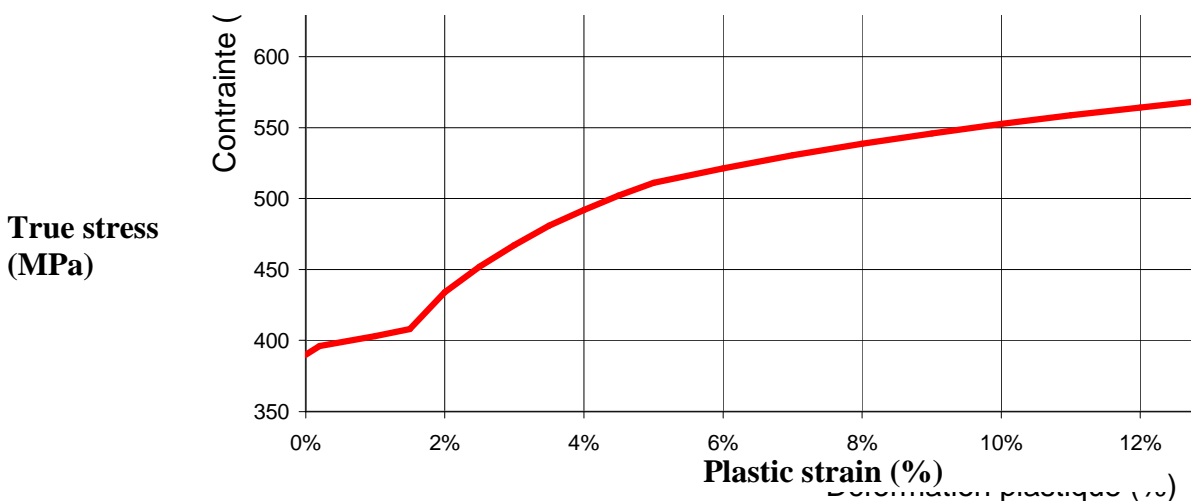
Figure 13: law of steel behaviour

The Failure Criterion is defined as a critical stress corresponding to the strain at the UTS (Ultimate Tensile Strength). So, the critical stress is the UTS value corrected by the strain :

For this steel, the ultimate tensile strength is got for a strain of 12.2% on the tensile curve. In the FEM analysis, the equivalent stress is calculated and compared with the critical stress in each finite element. When the equivalent stress equals to the critical stress in all finite elements under the defects through the thickness, the failure is considered to have been reach. Steel and Clock-Spring data are respectively given in tables 4 and 5. The graph of the steel behaviour law used in the FEM calculation is shown in figure 13.

Yield strength	390 MPa
UTS	509 MPa
Strain of the UTS	12.2 %
Critical stress	571 MPa

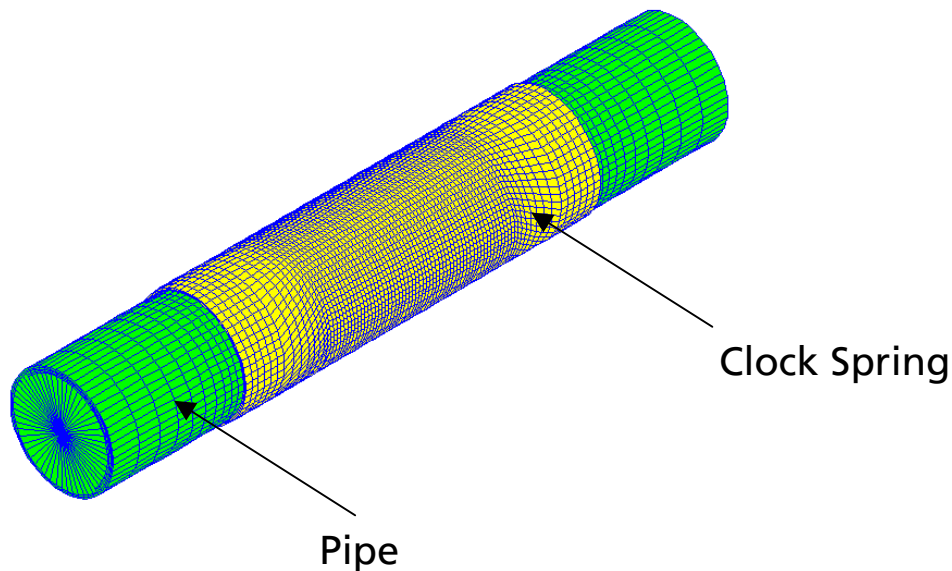
Figure 14 : numerical model of the tube and the Clock Spring

Here, a model of the test with Clock Spring was created; the elements are Quadrilateral elements with eight nodes and one point of integration to gain in computing times and preserve the quality of the results. The model is composed of three parts, the tube, the filler and Clock Spring. (Figure 14)

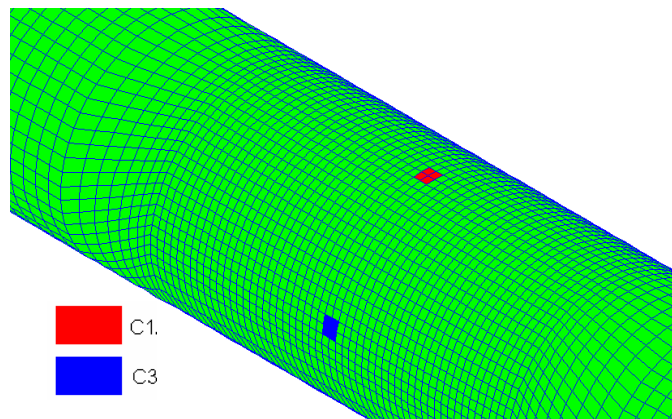
figure 15 : model of the gauges on the defect

The strains are also calculated to compare with the gauges results. The gauges on the defect are in the figure 15.

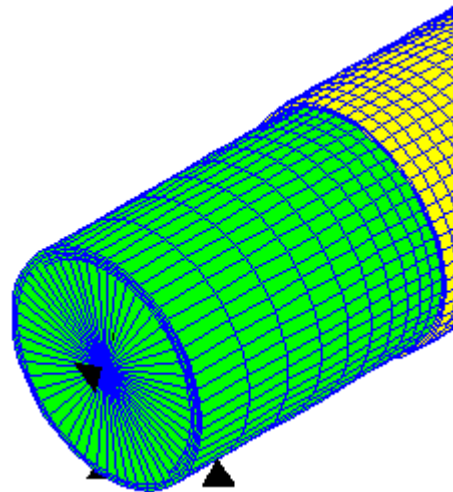
Figure 16: place of the boundaries conditions

Then figure 16 shows the place of the boundary condition with the symbol (black triangle). Four nodes were locked in the two directions X and Y which represent the square that the tube test was putting. A central node is locked in Z direction (longitudinal direction).

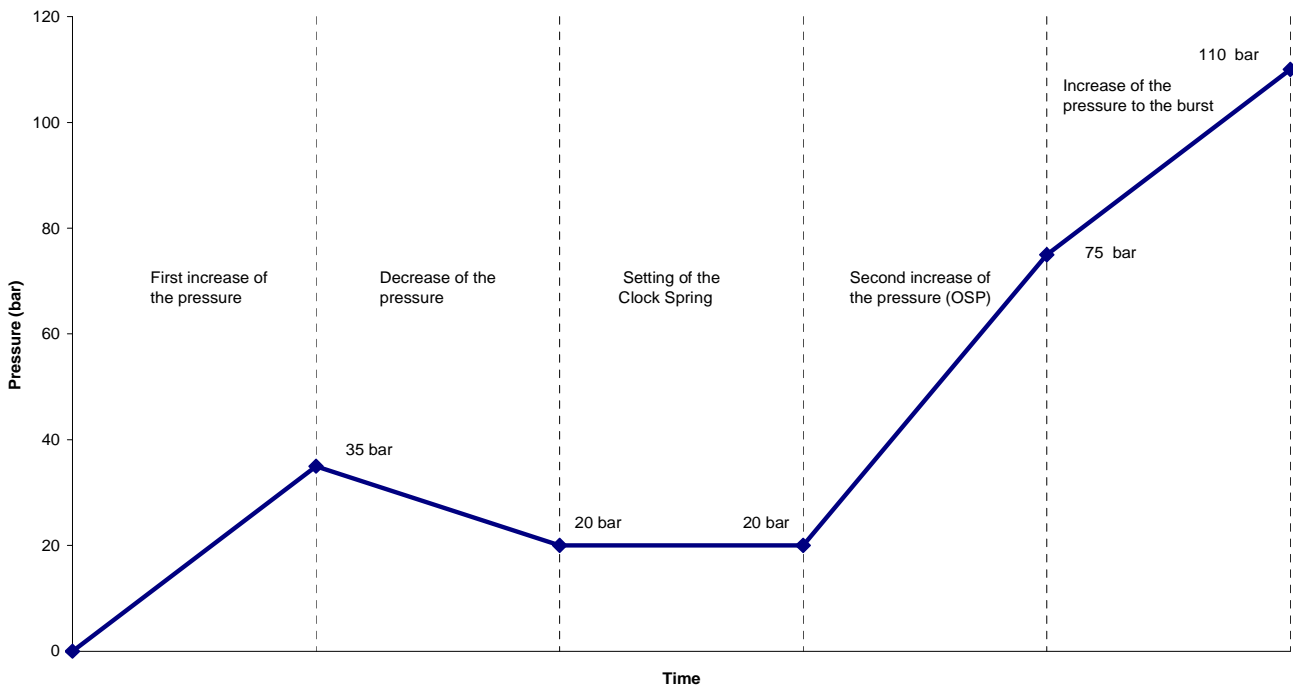
Figure 17: different steps of loading

The relevance of the finite elements model is appreciated by comparing numerical and experimental results (table 4). The calculation stage has been done like below and in the figure 17:

- First increase of the pressure at 35 bar
- Decrease of the pressure at 20 bar
- Setting of the Clock Spring at 20 bar
- Second increase of the pressure (OSP) at 75 bar
- Increase of the pressure to the burst

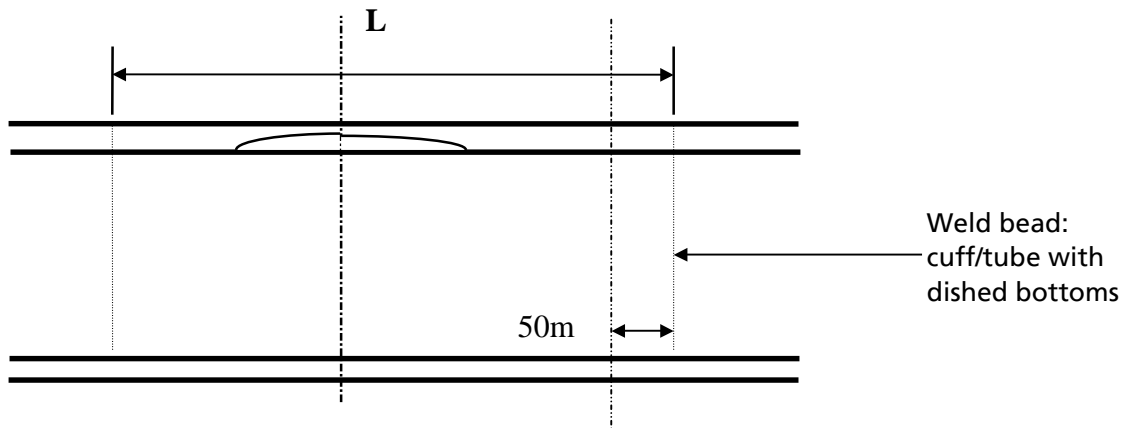
For each pipe tested, one carries out 4 measurements diameters to 3 phases of the test:

Measure in the plan passing by the centre of the defect

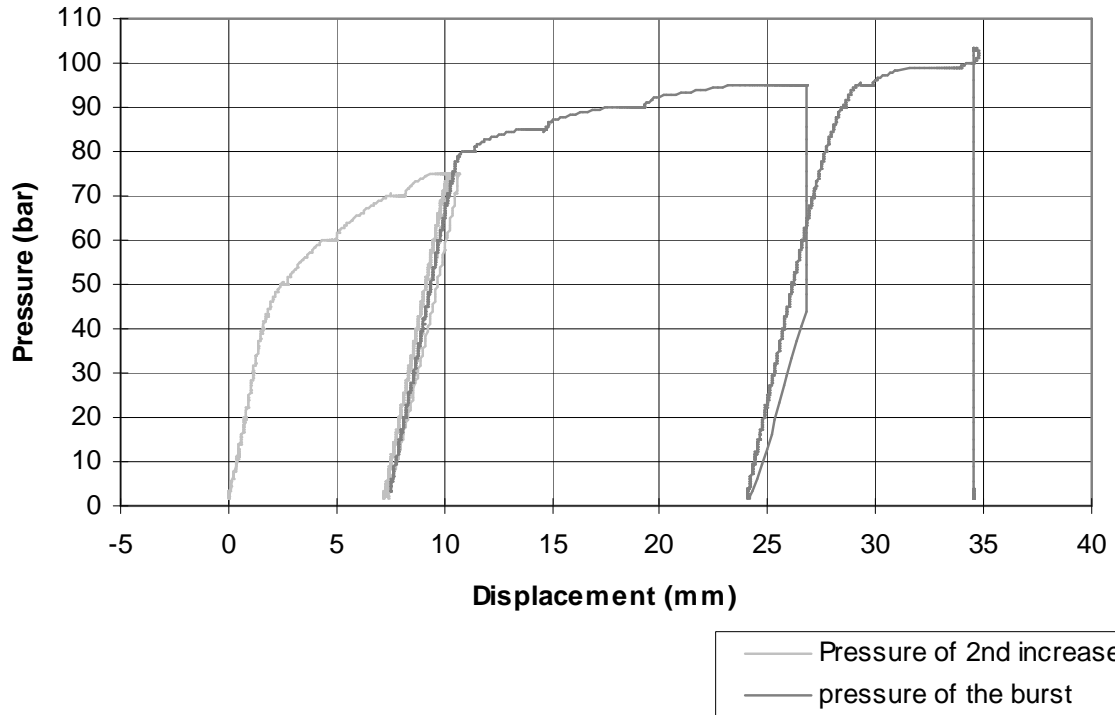
### Pressure vs displacement

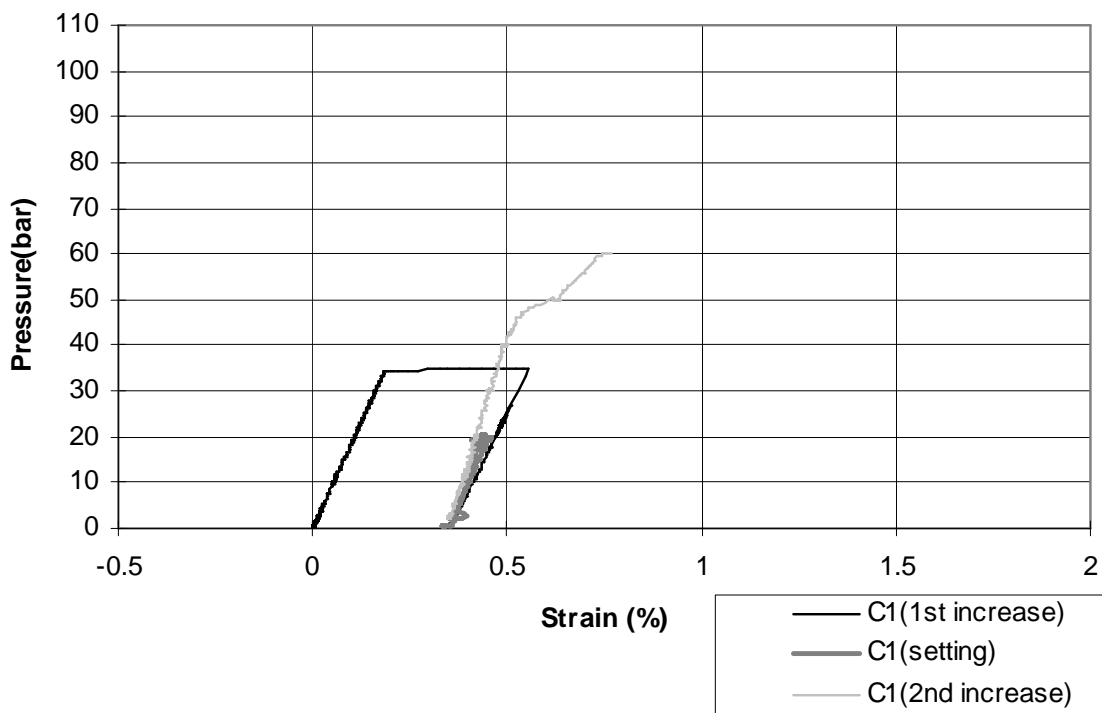
### Pressure vs circumferential strain C1

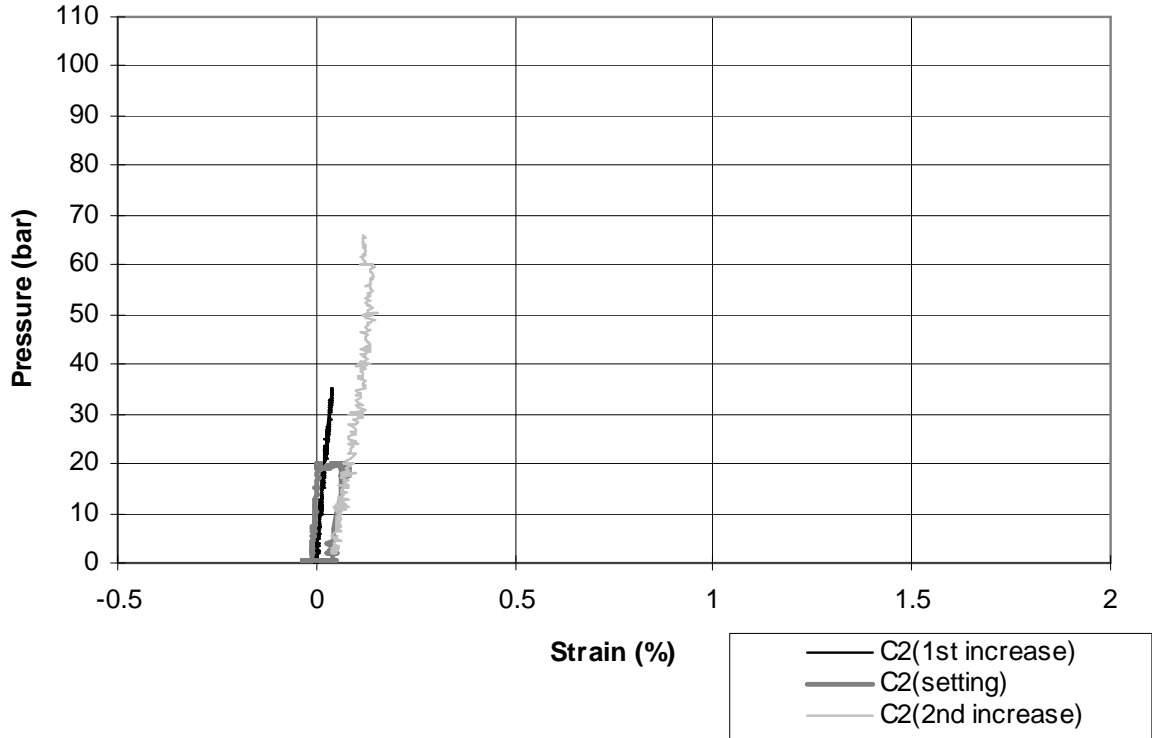
Pressure vs circumferential strain C2

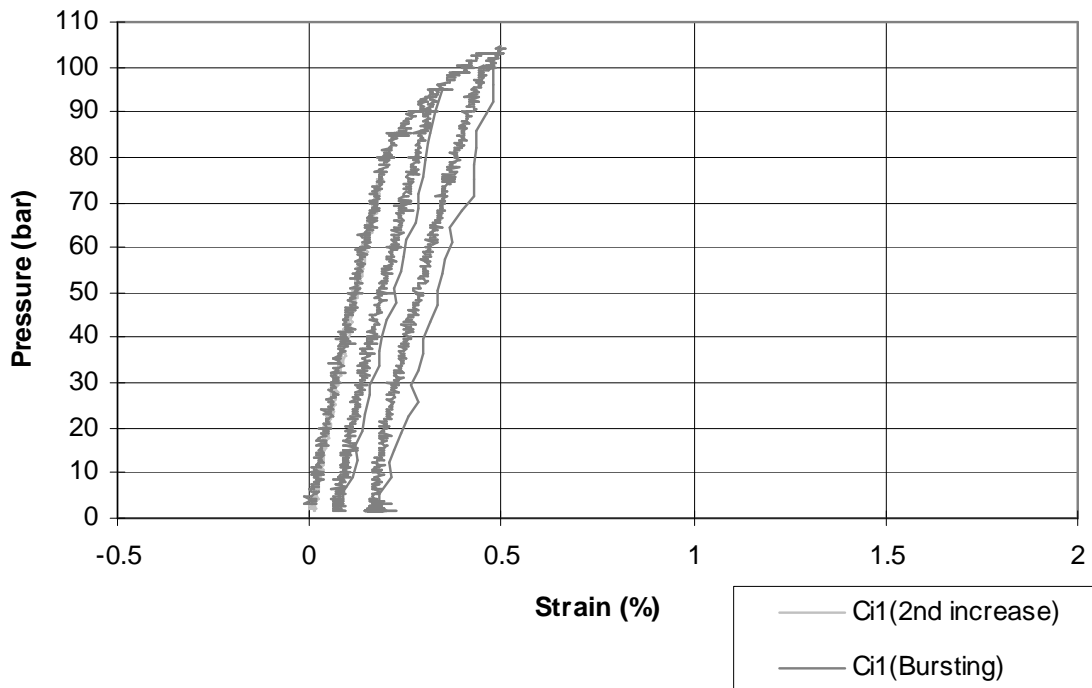
Pressure vs circumferential strain Ci1

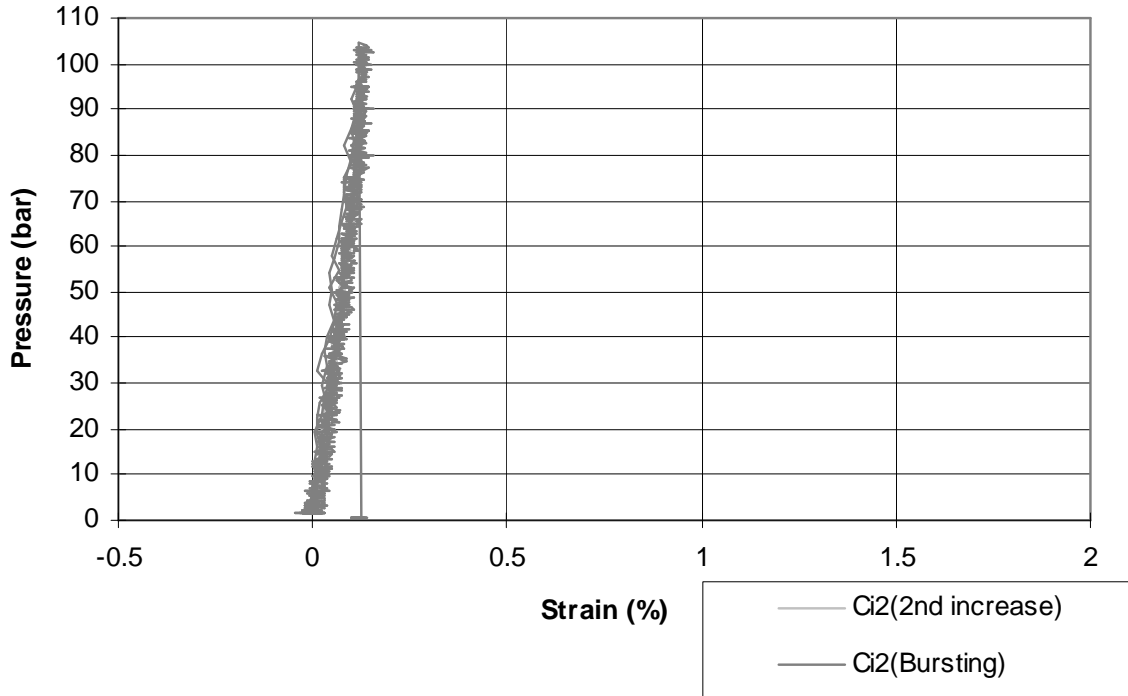
Pressure vs circumferential strain Ci2

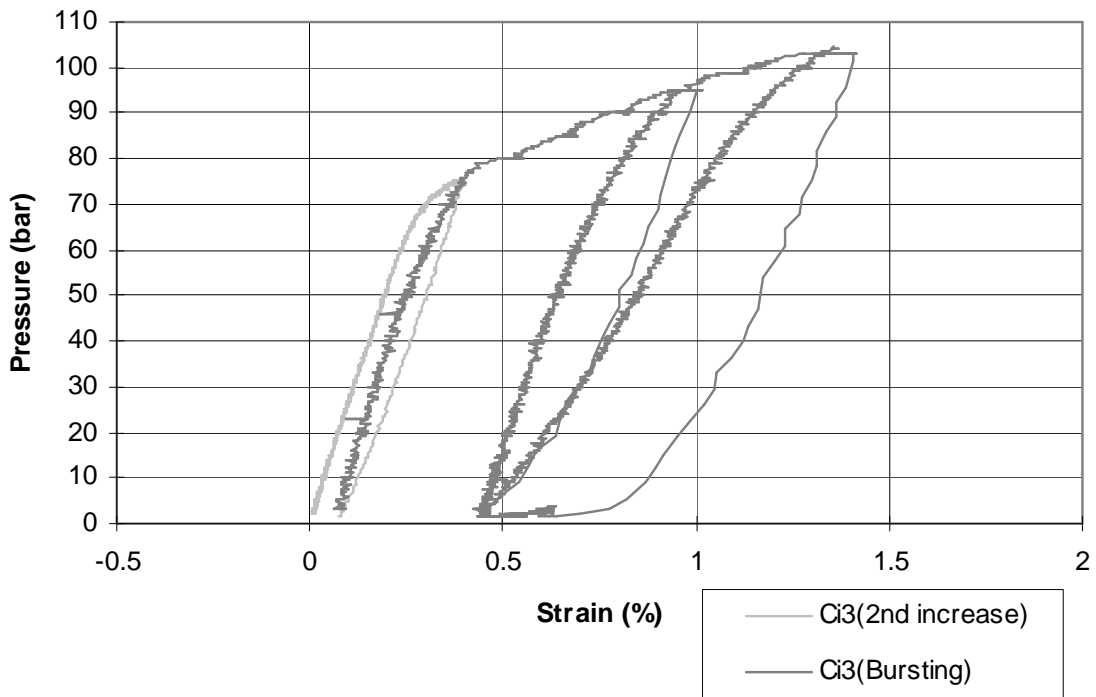
Pressure vs circumferential strain Ci3
